What Lies Beneath

Healthcare Estates

7th October 2014

Envirosafe UK Ltd

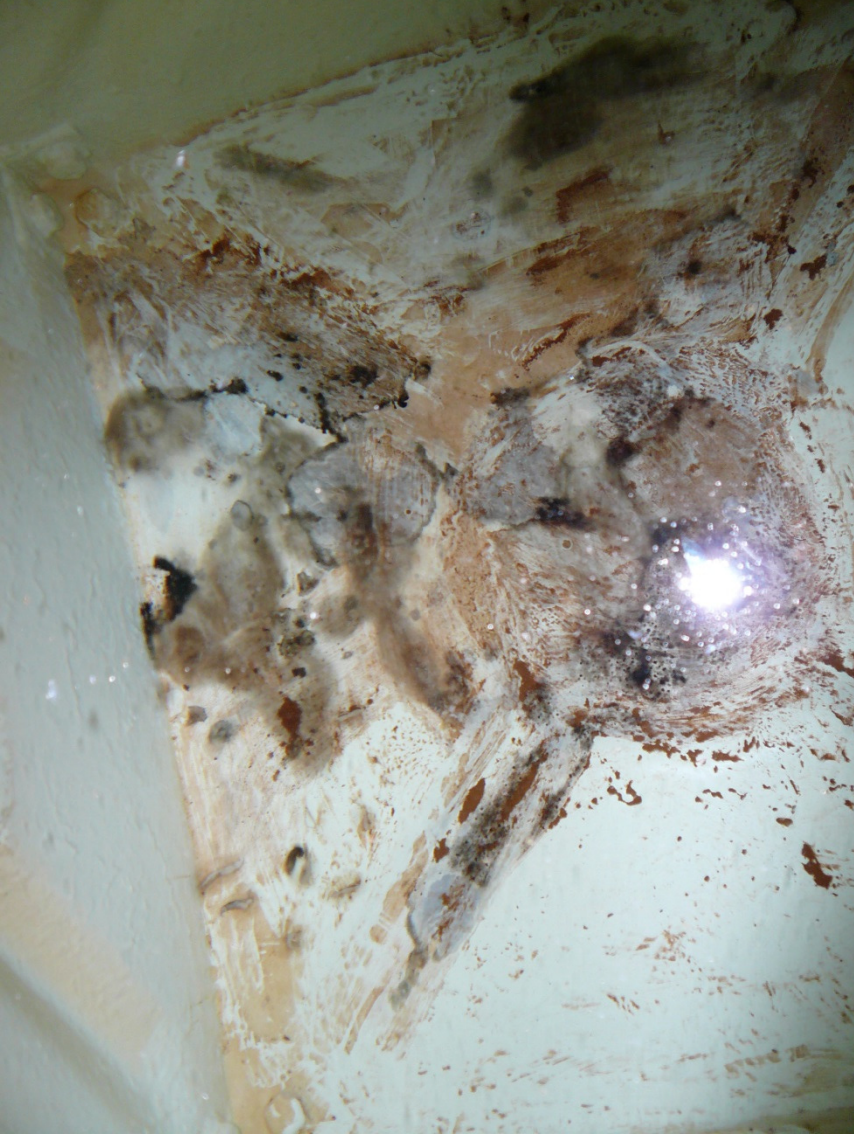
Mould growing in poorly mixed paint

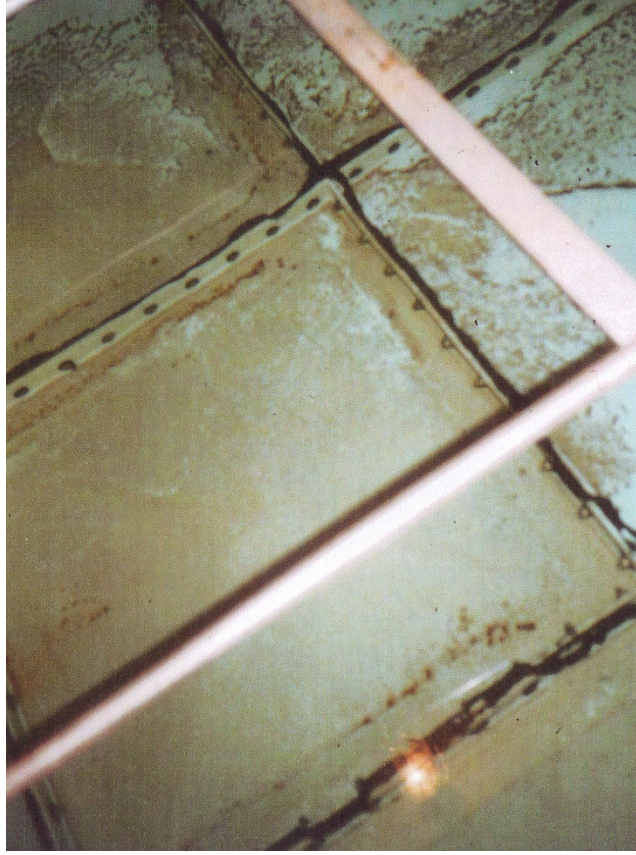
Early examples bled
sealant and could
leak

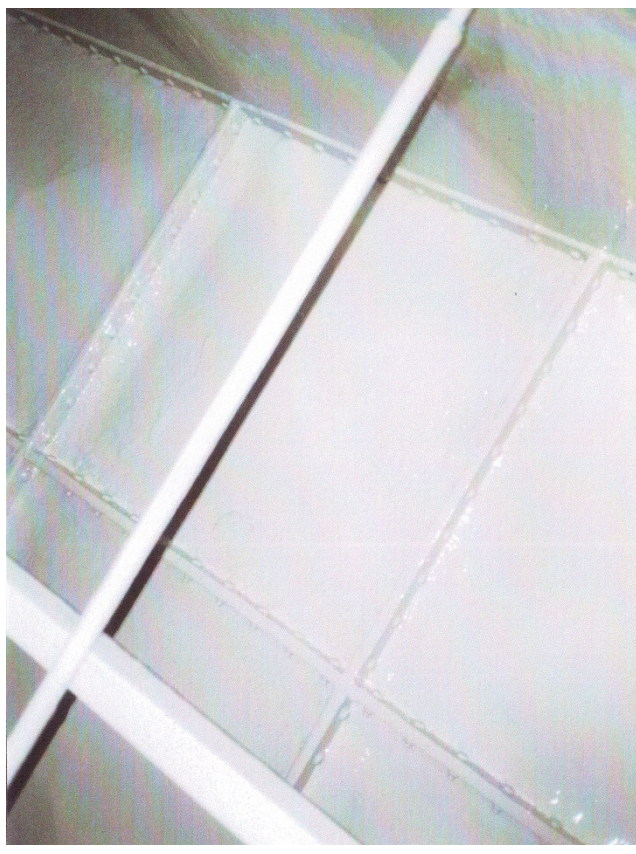
Resulted in
recoating with
flexible paint

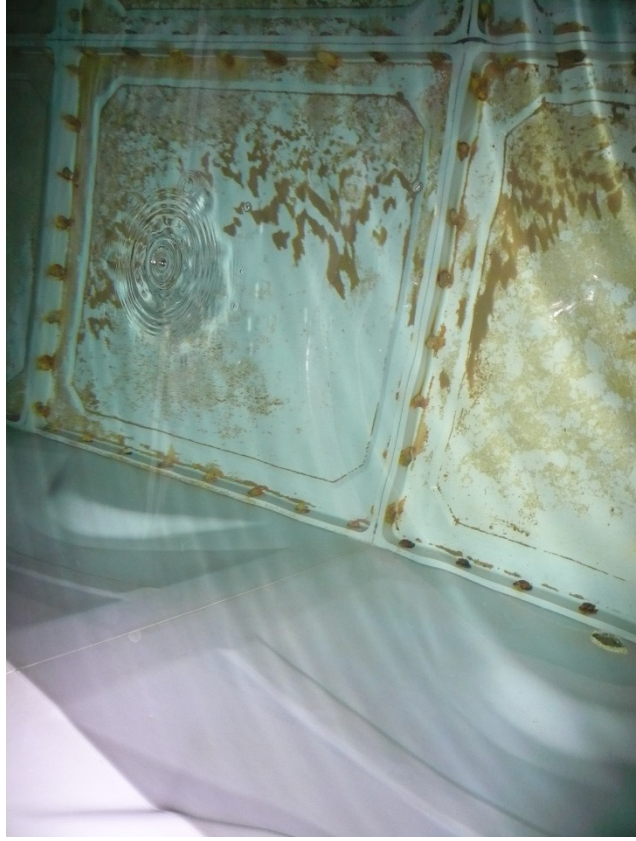
Mild Steel Bolts – causing
most of the debris in the tank!

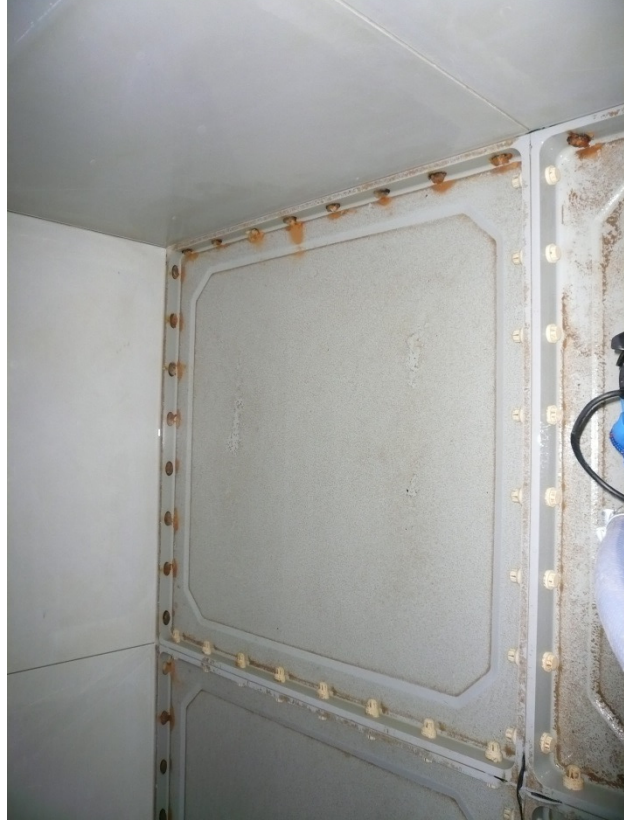
Half plastic coated bolts –
where's the logic?

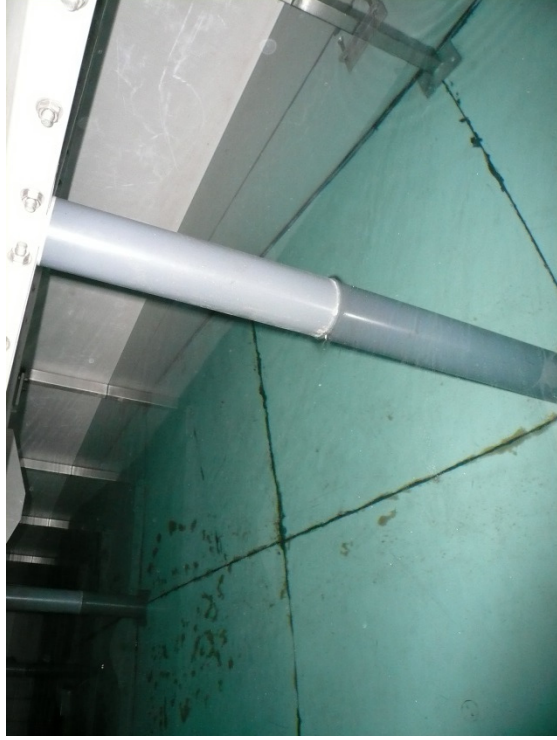
Concealed Structures
DH EFA/2013/004
HSG274 Part 2 Fig 2.12 Moderate
Risk

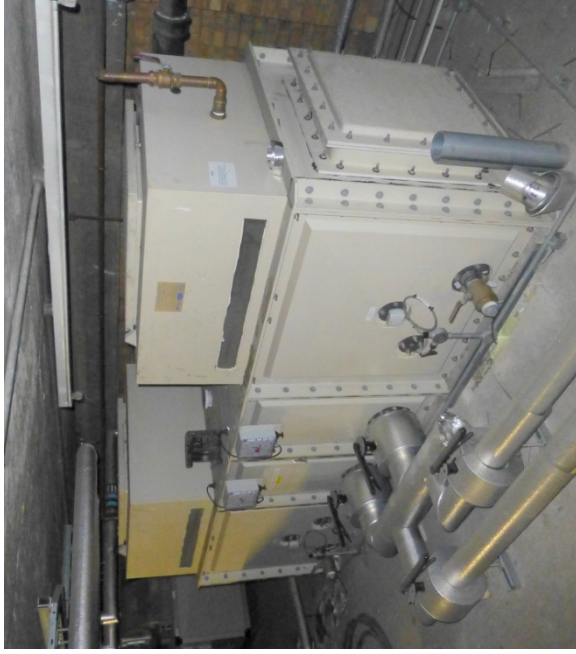
Gel Coat Failure – HSG274 P2. Fig 2.12 High Risk

Tank installed in
2013

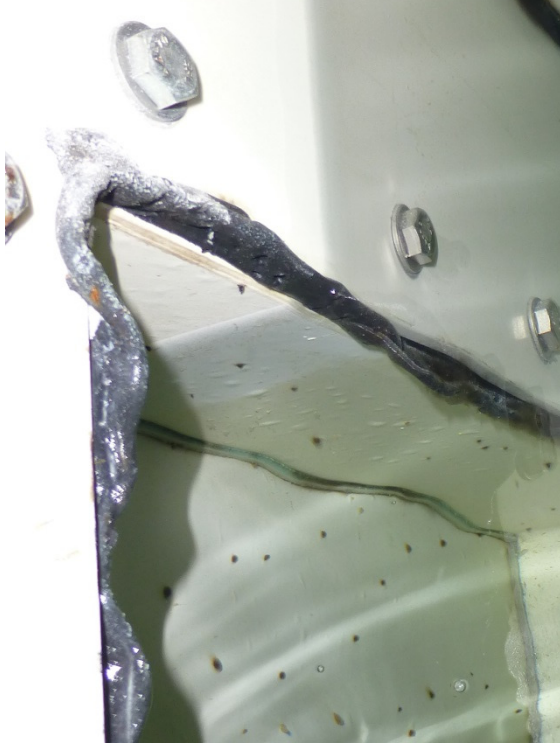
Gel coat failure in 2013
on side hatch only

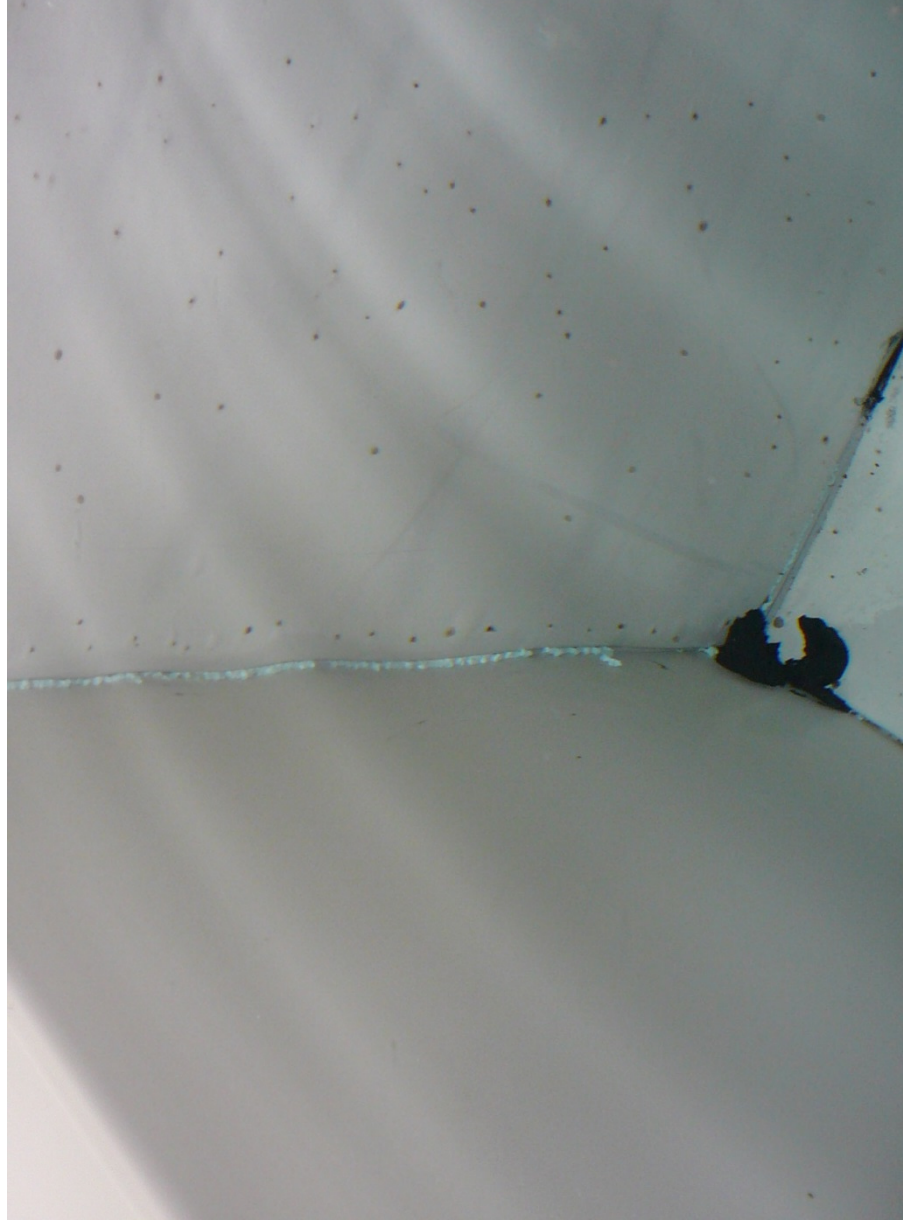
One Section is fine, the adjacent one is covered in cysts

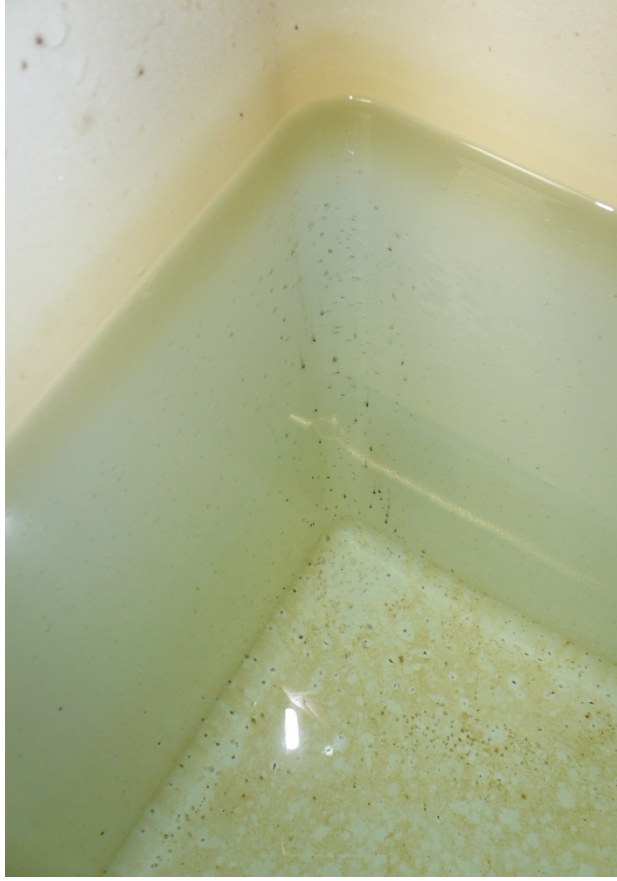
One piece tank – corners often fail due to either inconsistent brush application of gel coat resin or insufficient pressure when rolling out the air between layers of fibreglass.

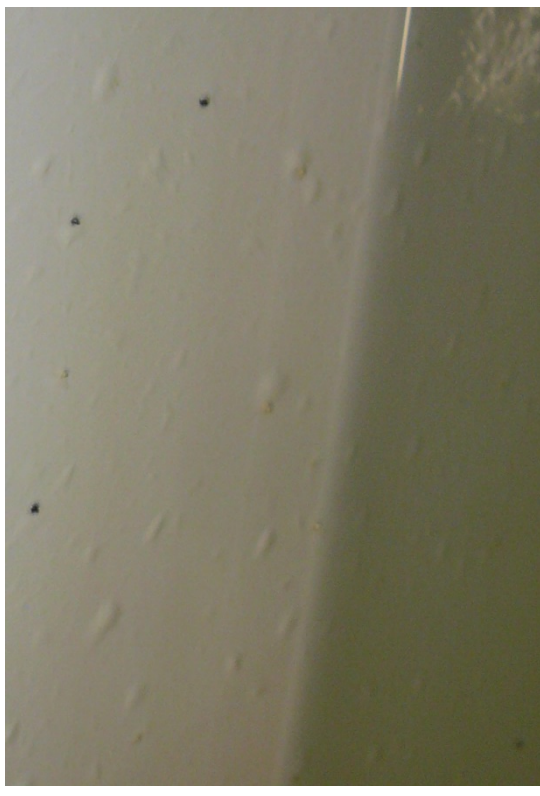
Bubbled/blistered surface is the first signs of osmosis
