What Lies Beneath

Healthcare Estates

7th October 2014

Envirosafe UK Ltd

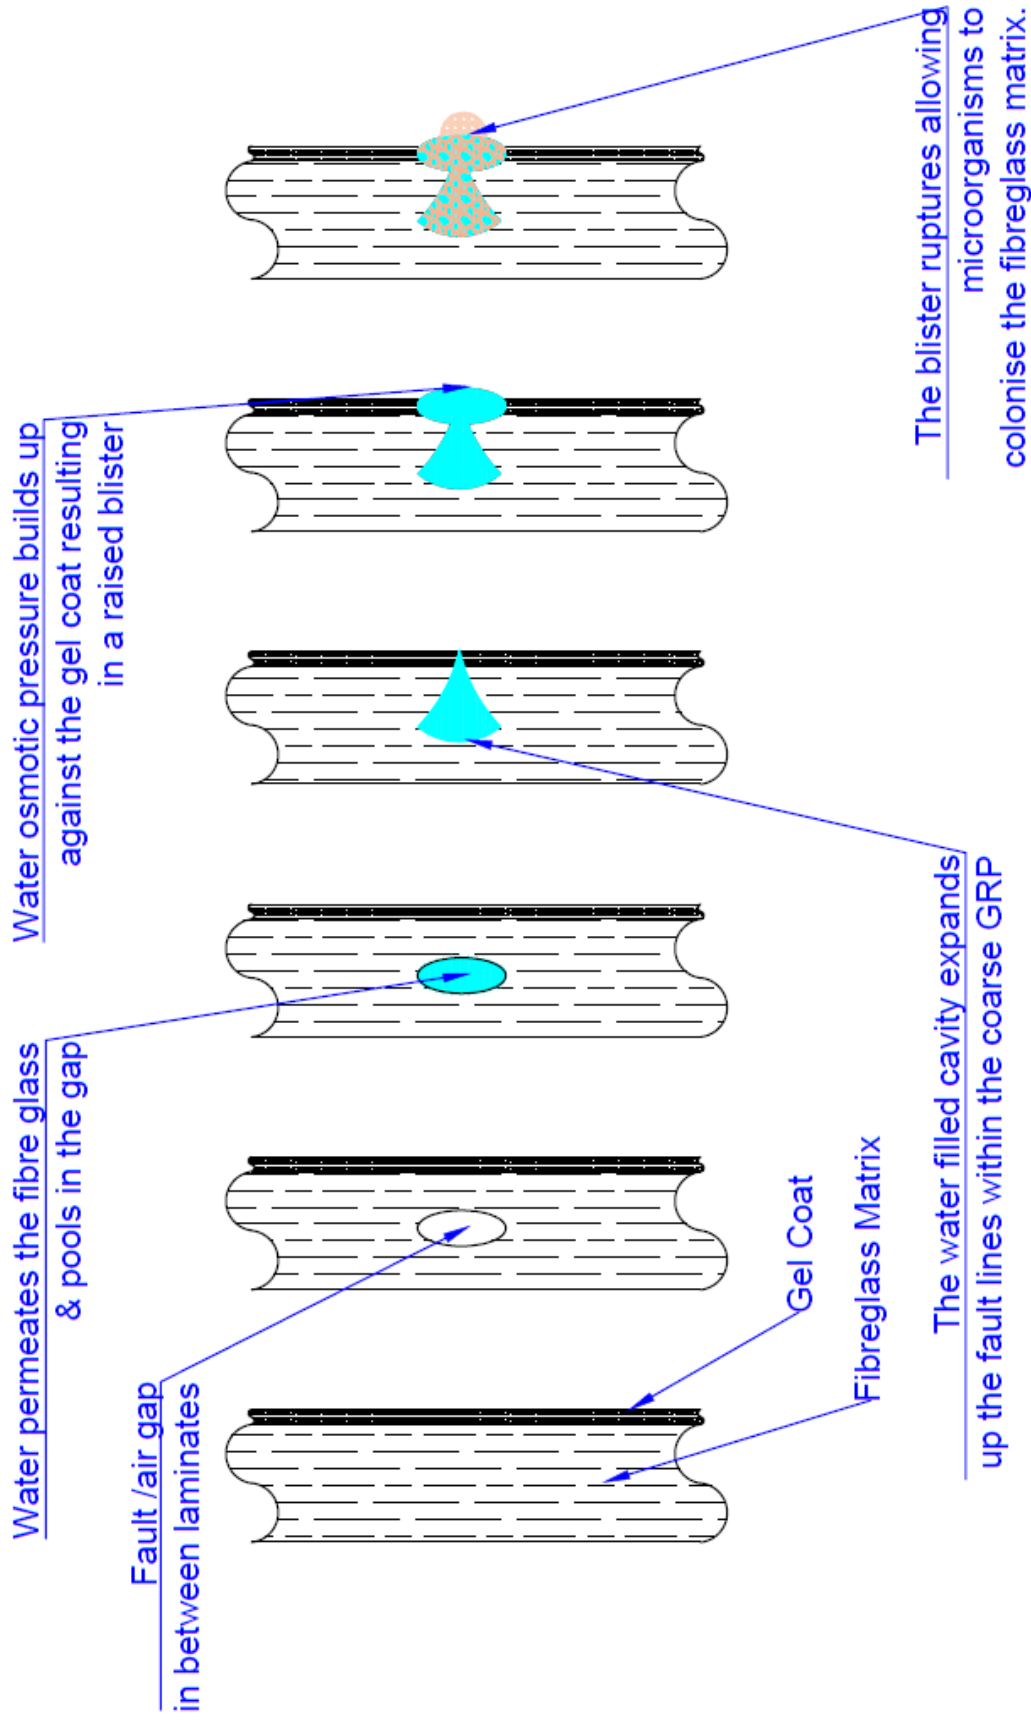
Gel Coat Failure

One mechanism of failure

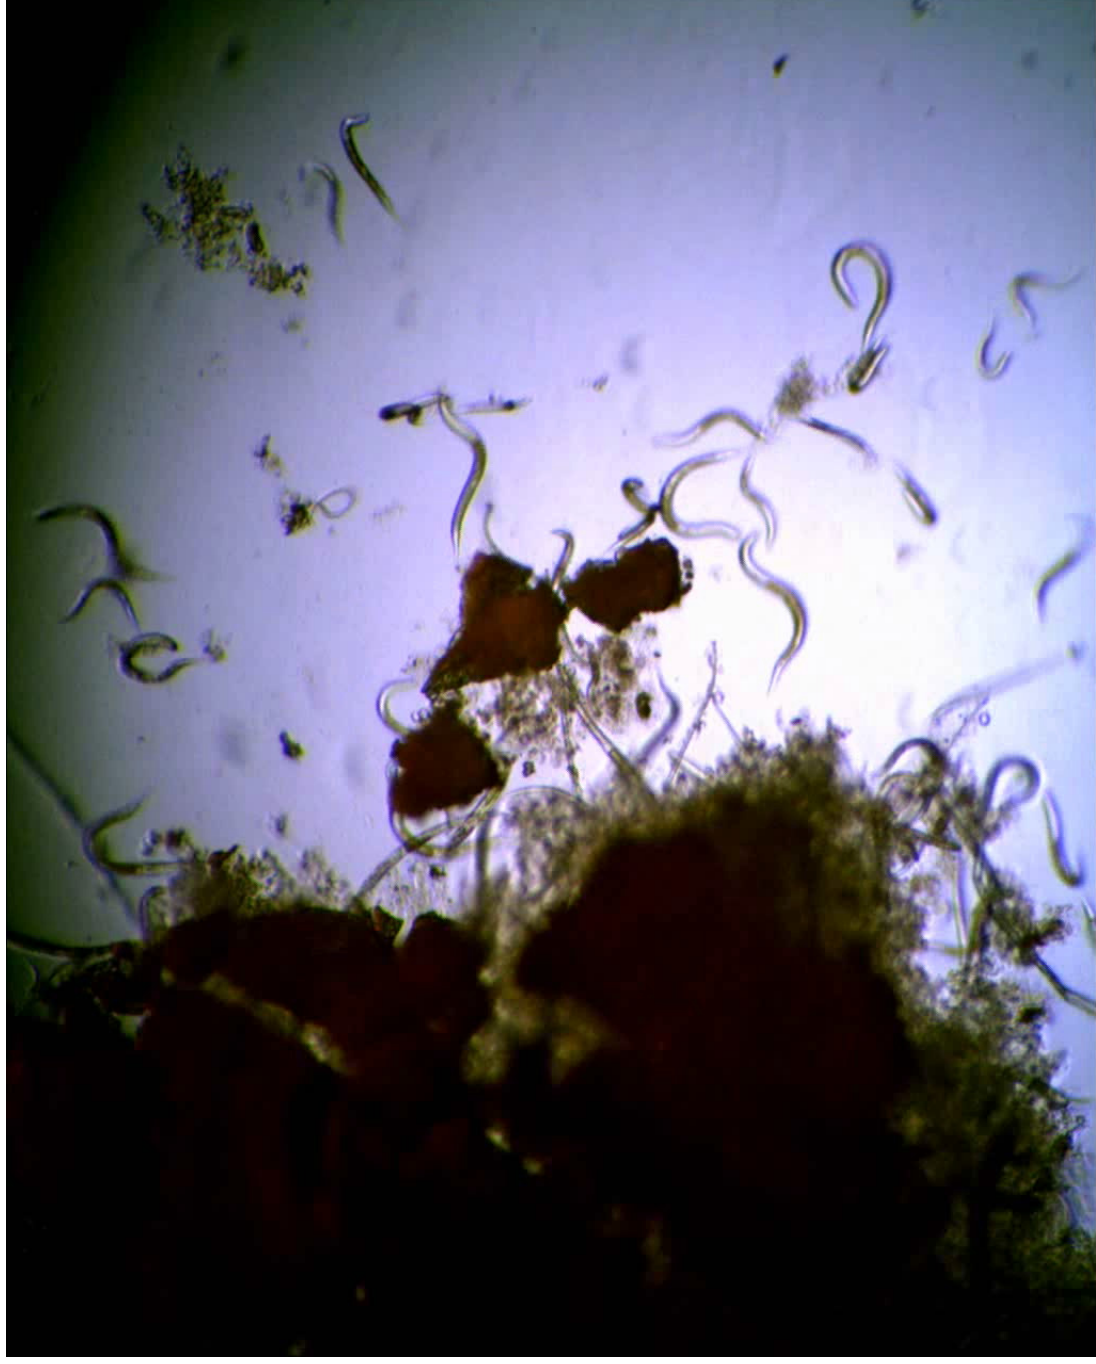
Nematodes & biofilm

- ❑ Naturally, when faced with worms swimming around in your cold water storage tank, the first response is to clean the tank.
- ❑ Unfortunately we found that the cysts (and worms) were visibly back within 2 weeks.
- ❑ Chlorination tried at double the recommended concentration of chlorine for double the time (>100mg/l free chlorine for 2 hours) – cysts removed from the tank surface prior to chlorination.
- ❑ Nematode within the biofilm still alive up to 36 hours in 100mg/l chlorine!

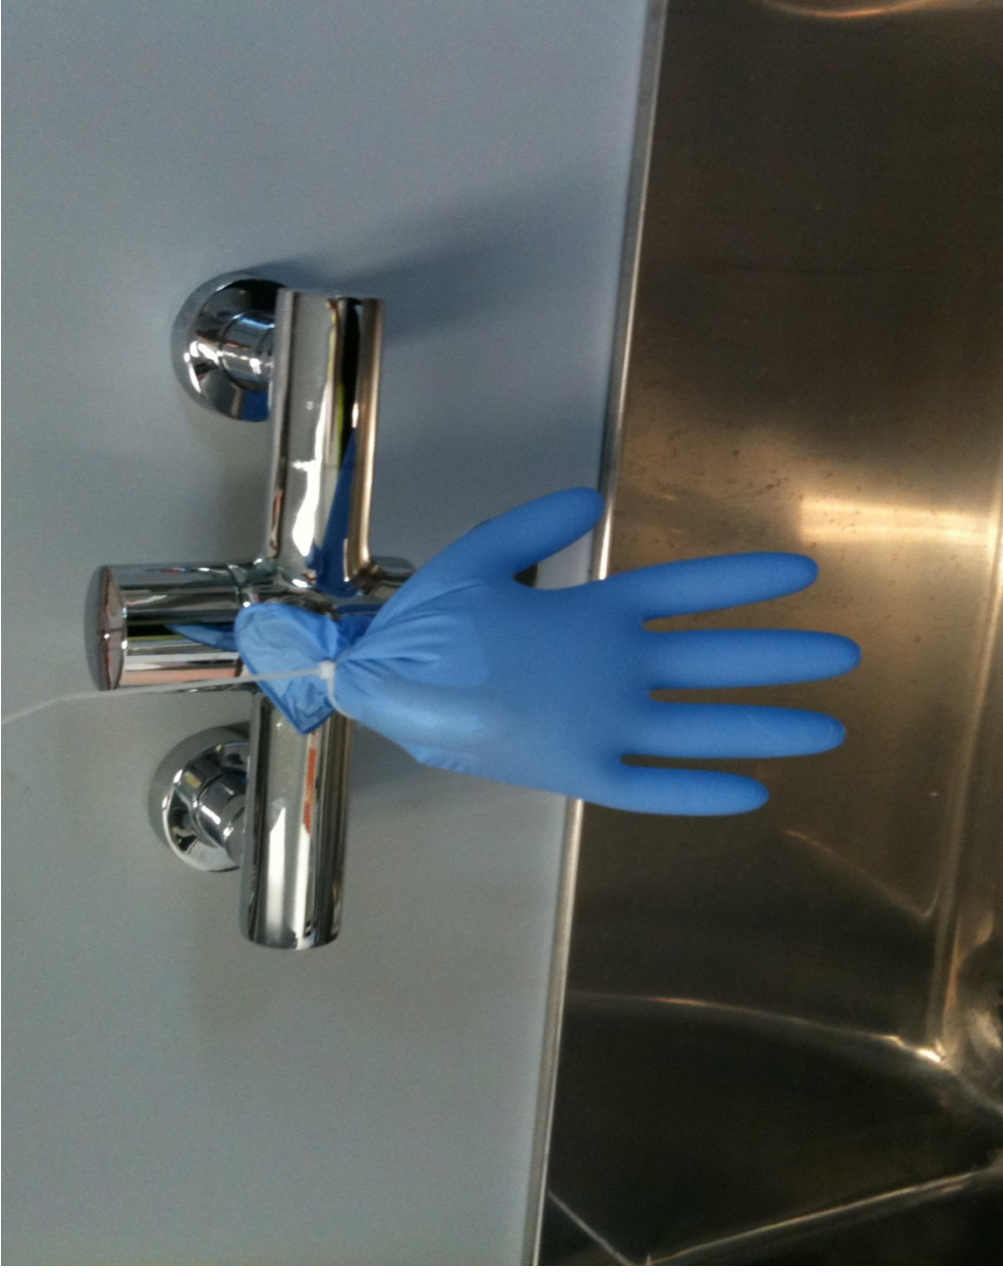
- ❑ Back in 2009 we started working with Homerton Hospital & the HPA following the refurbishment of their SCBU ward.**
- ❑ The plumbing contractor had failed to carryout an adequate chlorination of the pipework and a biofilm had been allowed to become established.**
- ❑ Working with the HPA we agreed on what levels of pseudomonas aeruginosa were deemed to be acceptable – these levels were then adopted by the HPA and have since become HTM04 addendum.**

- ❑ **Chlorination No1 - >80mg/l chlorine for 1 hour**
 - Results were poor after 5 days.
- ❑ **Chlorination No2 - >80mg/l chlorine for 1 hour, all plastic filters removed from Markwik IR taps and boiled.**
 - Results deteriorated after 2 weeks (still working on <80cfu PA per ml being acceptable)
- ❑ **Chlorination No3 - >80mg/l chlorine for 2 hours, outlets bagged and soaked for >1 hour**
 - French Limits adopted – pseudomonas levels still too high on cold services
